THE CURRENT STATE

A DEEP DIVE INTO ONE OF THE BEST

OF EXCELLENCE

1969 DAYTONA RESTORATIONS EVER!

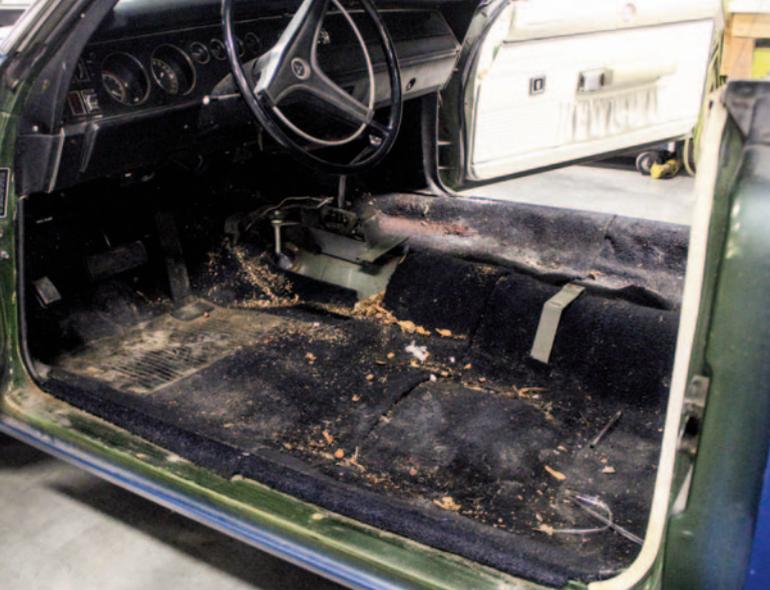
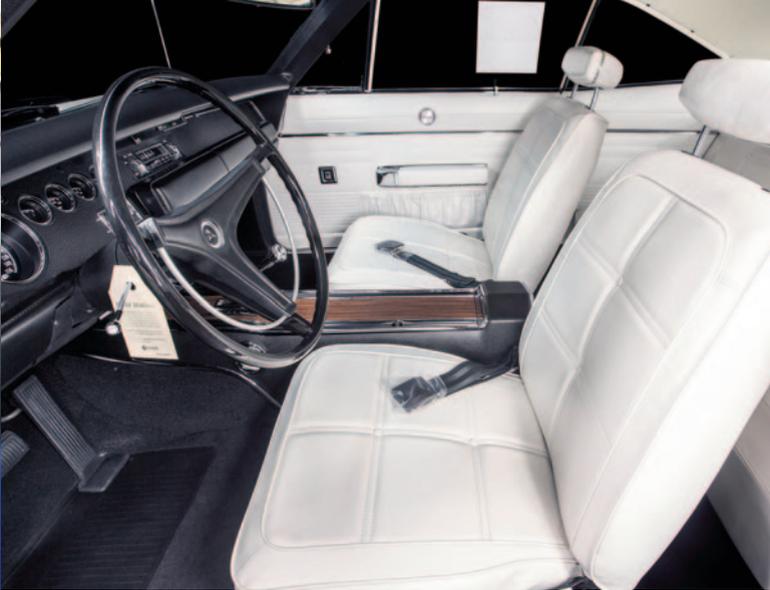
The contrast from the before and after is quite striking, however, beyond the new seat covers and headliner made from NOS material, the rest of the interior has been restored and reused right down to the carpet. Also, visible in the before photo, is where the blue paint ends over the green.

The teardown process on any car going under the knife at AMCR starts on the inside. “We start from the interior, and we move outwards,” Mike states. “On the inside we work from the top down by removing all the ancillary hardware that surrounds the headliner and move on from there.” On this Daytona, the bonus was that the forty-five-year dormancy in storage preserved it in excellent condition, which made the overall process much easier right out of the gate. Every part was noted on the lists and the outcome was very promising. The only items that required replacement were the headliner and the seat covers. Everything

else was restored to factory new condition. Originality at this level is not compromised when dealing with items like the headliner and seat covers. On this Daytona, Mike explains, “The original seat covers were beyond the salvageable point, so what I did was source NOS material that I then sent to Legendary Interiors and had them make a set to my specifications. With the headliner, since we have a vast inventory of original NOS headliner material in stock, it was as simple as having a new one made.”

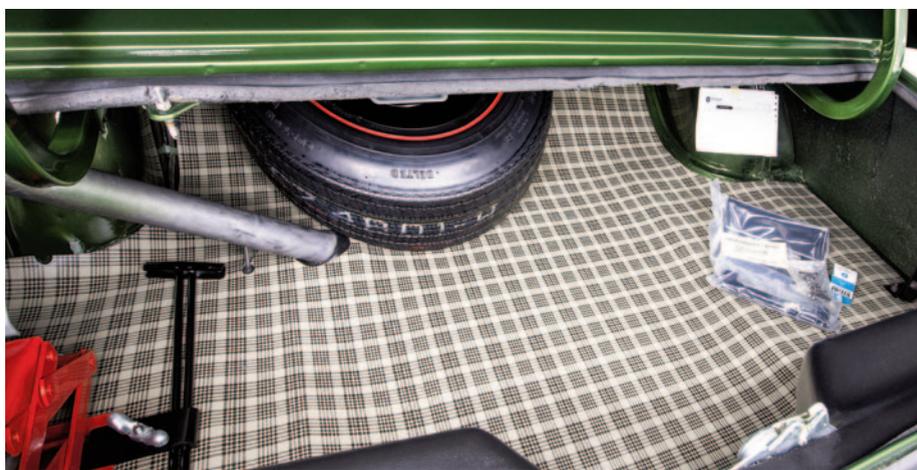
On a restoration that focuses on the assembly line process, the obvious details are with items like the NOS trunk mat, and the Daytona specific jack. However, items like the NOS license plate mounting hardware, or the “Vehicle Traveler” paperwork taped in the trunk area are the details that most shops either don’t bother with or simply don’t know the role they play in a top end restoration.

rear taillights and the plastic cover panels, which are easily cracked and often damaged or missing.” On Ronnie’s Daytona, these were not an issue. Daytona-specific pieces can be difficult and pricey to find, and on Ronnie’s car, the jack, which is unique to a Daytona, was missing. This is where a seasoned shop like AMCR can make the difference. Mike states, “I had one in inventory that I purchased a few years ago. Since these jacks are model-specific, you need to have an idea as to what you’re purchasing because they were reproduced for a while, and you can be easily fooled. There are also individuals that are selling similar ones that have been repainted and advertised as originals - they’re not.” He further adds, “We also had a correct date-coded NOS floor mat in our inventory and also acquired a correct date-coded spare tire.”

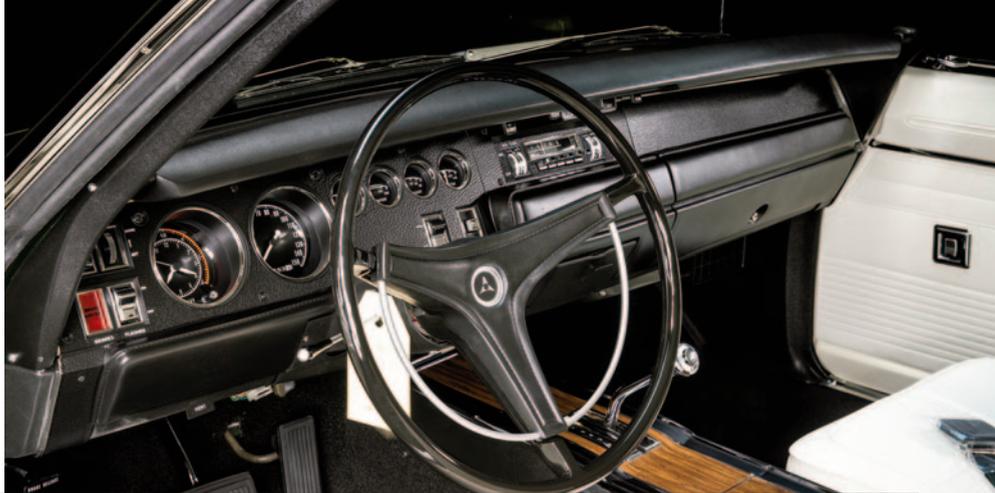
The finished dash was fully restored by sister company Instrument Specialties as part of the restoration process. On this car, because of its excellent condition, every item was restored and reused. On average, one of these complete dash assemblies can take up to eight months to restore.

parts given a fresh coat of chrome. This task was an in-house process that was executed by sister company Instrument Specialties. Removal of the heater box and steering column also kicked off the teardown process into the engine bay.

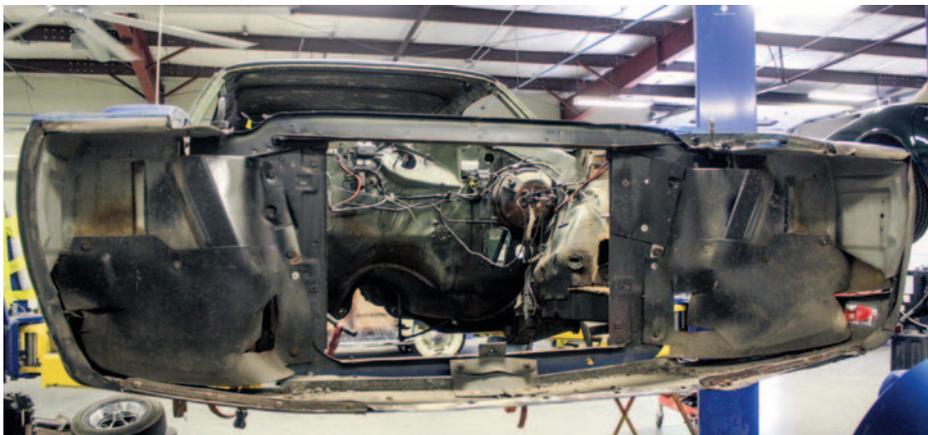
After the drivetrain is removed, one of the first things that takes place is an assessment of the existing parts which get noted on the running lists. All documentation on any factory markings is also done at this step. As an example, visible in the photo is the upper radiator hose, which likely was replaced because of the non-factory hose clamps.

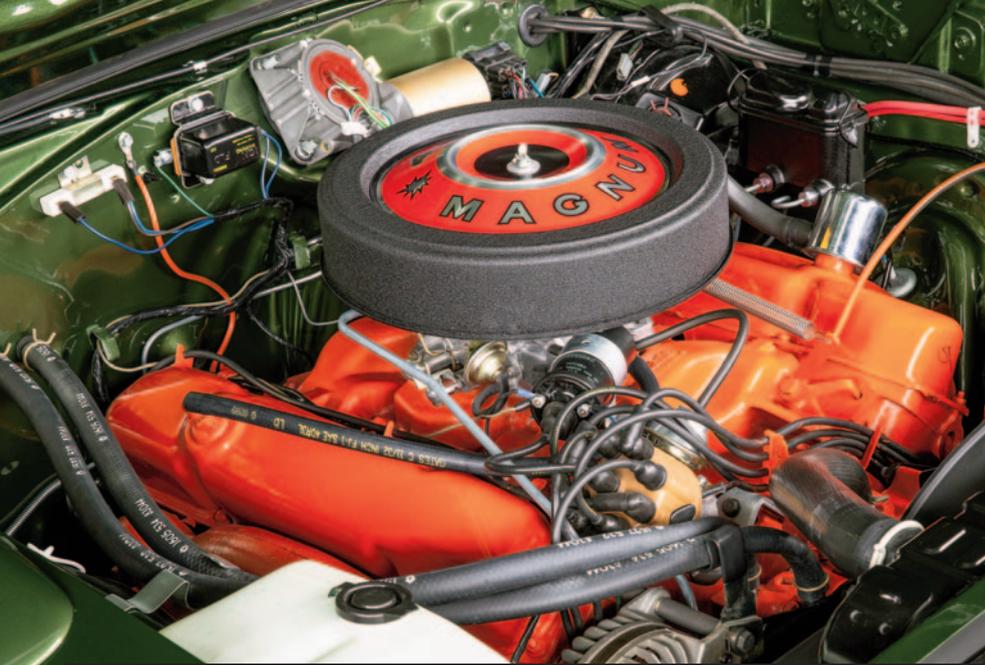
The goal for any restoration at this level is to excel when it comes to judging. On this Daytona, the finished engine compartment is representative of that quest. Getting to that level required all the parts to be original OEM with the correct date codes.

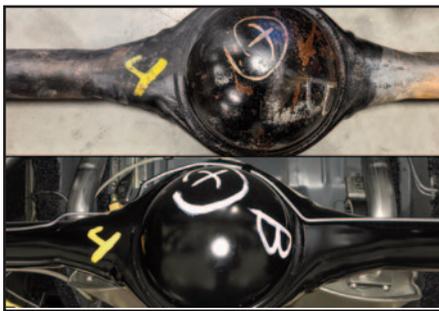
The before and after of the 8 3/4" rear end housing shows another aspect of the documentation that takes place with all the various assembly line markings.

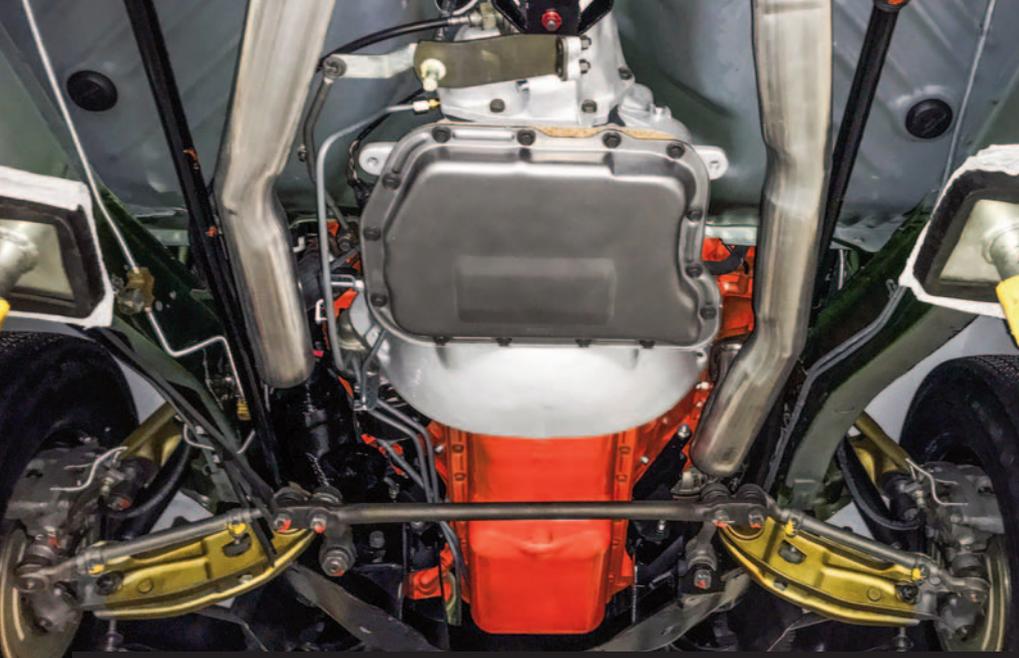
While some shops like to spray paint the Cosmoline look on the lower control arms, AMCR always does their restorations by duplicating the Cosmoline part with the real stuff. There is no mimicking this process with paint.

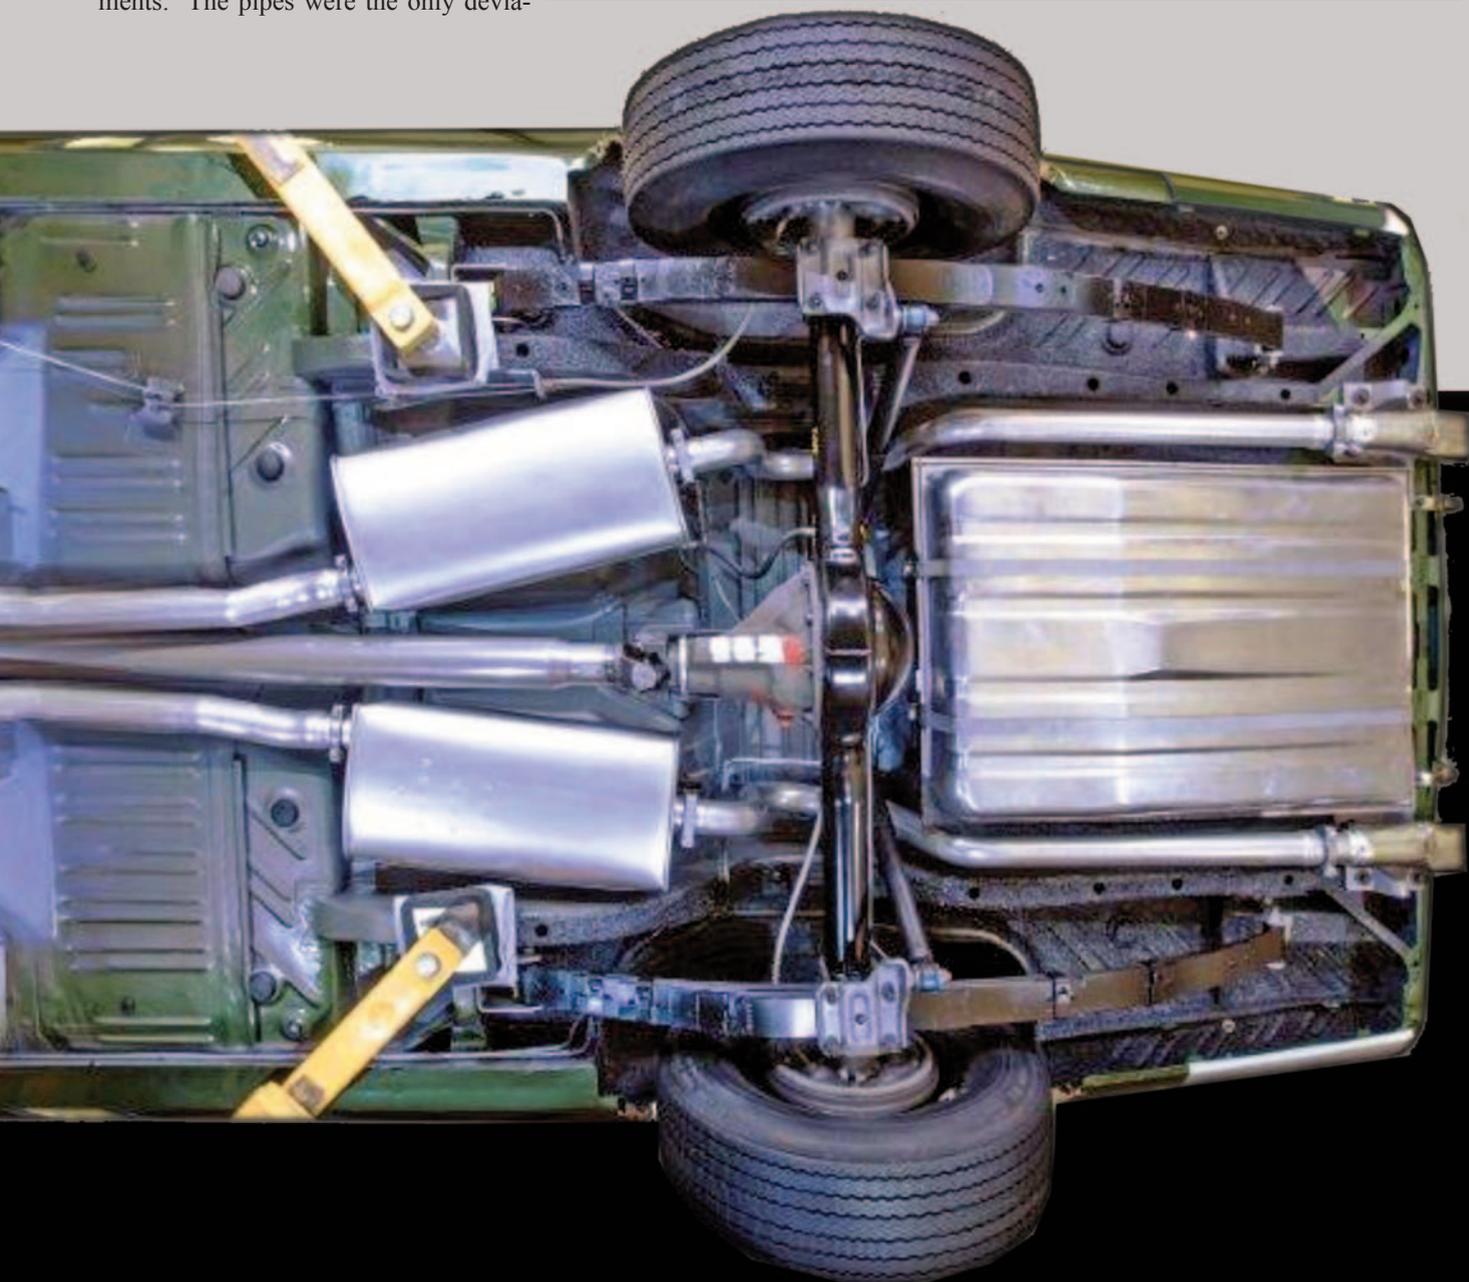
Another important element was the addition of a set of NOS tires at all four corners fitted to the original 14" Road Wheels.
